Proposed Strategic Housing
Development at the Former
Doyle's Nursery and Garden
Centre and Benoni,
Brennanstown Road,
Cabinteely, Dublin 18.

Quality Audit

Brennanstown Quality Audit

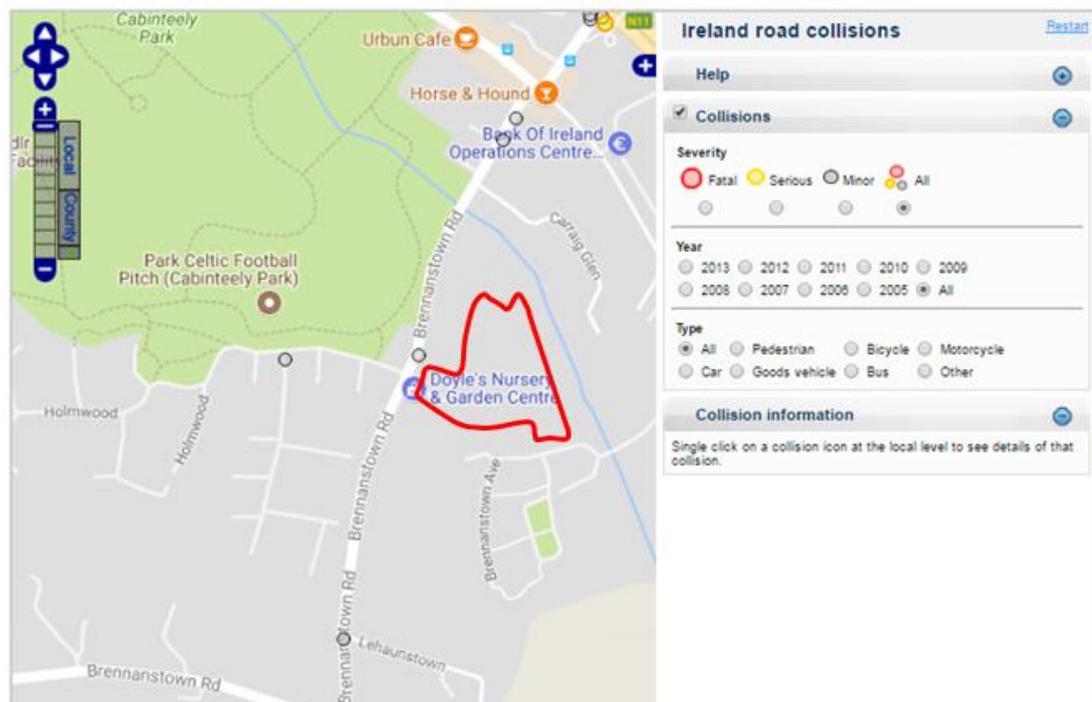
- The RSA database of road collisions was examined to establish if there are any existing safety issues in the vicinity of the site that were not evident from the site visit. The database provides collision records for the period 2005 to 2013, with Figure 2 below outlining the recorded collision locations over the nine year period.
- One minor collision was recorded along Brennanstown Road in the vicinity of the proposed development site. This occurred in 2008 and involved a single motorcyclist.

Figure 2 RSA Collision Records (2005-2013) in vicinity of the study area (www.RSA.ie)

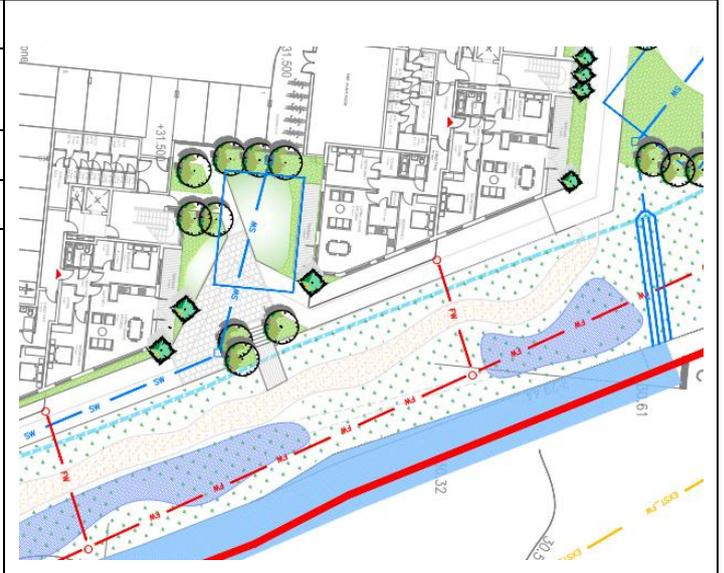
Problem 4.1.2	
<i>Location</i>	Cycle Parking to rear of Apartment Blocks
<i>Drawing</i>	1395 4072 Podium Level
<i>Summary</i>	Shared surface not indicated
<i>Description</i>	
<p>Access to the residential cycle parking is provided to the rear of the apartment blocks. No warning tactile or signage has been provided on the path to indicate that this path is a shared surface. This could cause confusion for pedestrians and cyclists alike, which could result in collisions.</p>	
Recommendation:	
<p>Appropriate signage and tactile paving should be provided to indicate the shared surface.</p>

Paragraph No. in Safety Audit Report	Problem Accepted (yes/no)	Recommendation accepted (yes/no)	Alternative measures (describe)	Auditor's Accepted Measure
4.1.1 Podium Level Access Clarification should be provided on the access arrangements to the podium level, with appropriate dropped kerbs and tactile paving provided.	Yes	Yes - Dropped kerbs and tactile paving to be provided to facilitate cyclist and pedestrian access.		Yes
4.1.2 Cycle Parking to rear of apartment blocks Appropriate signage and tactile paving should be provided to indicate the shared surface.	Yes	Yes – Appropriate signage and tactile paving will be provided as per the Traffic Signs Manual, to clearly indicate that there is a shared surface area at this location.		Yes

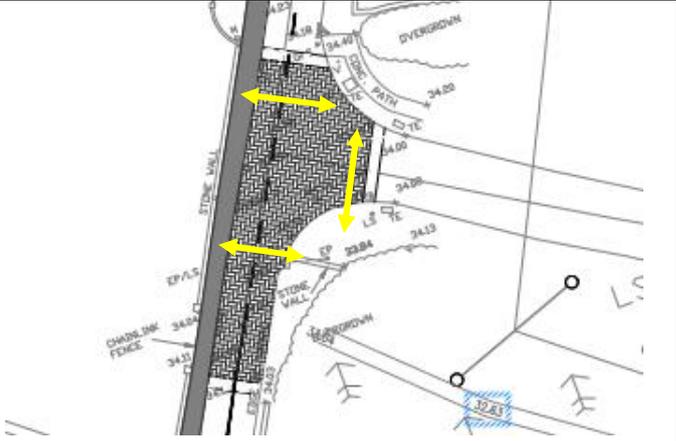
Problem 5.1.2:

<i>Location</i>	Brennanstown Road/Carrig Glen Junction	
<i>Drawing</i>	60541707 – SHT – 10-C-0100	
<i>Summary</i>	Lack of crossing facilities	
Description		
<p>There are no crossing facilities provided for pedestrians through the junction. Lack of crossing facilities creates a barrier for vulnerable road users.</p>		
Recommendation:		
<p>Appropriate crossing facilities should be provided for pedestrians through the junction</p>

Section 1 – Issues relating to proposed Brennanstown Road Upgrade (footpath on the western side of the road)				
Paragraph No. in Safety Audit Report	Problem Accepted (yes/no)	Recommendation accepted (yes/no)	Alternative measures (describe)	Auditor's Accepted Measure
5.1.1 Brennanstown Road / Bray Road Junction Tactile paving and dropped kerbing should be provided to allow pedestrians to cross safely.	Yes	Yes – tactile paving and dropped kerbs have been introduced 60541707-SHT-10-C-0100_RevB		Yes
5.1.2 Brennanstown Road at Carrig Glen Junction Appropriate crossing facilities should be provided for pedestrians through the junction	Yes	Yes - Tactile paving has been provided on the northern arm of Brennanstown Road. See AECOM drawing no. 60541707-SHT-10-C-0101.		Yes

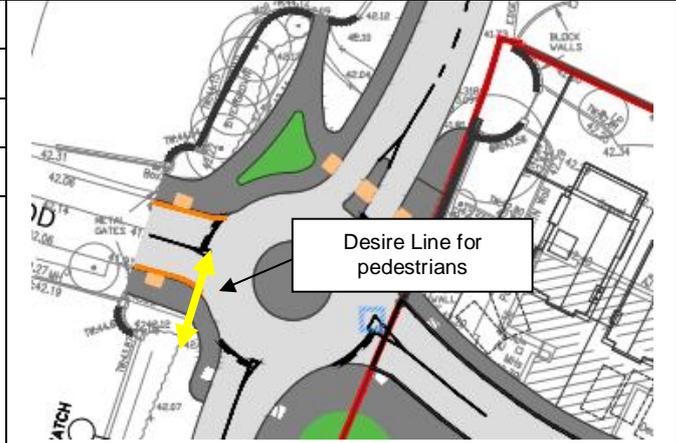
Problem 5.1.3:

<i>Location</i>	Roundabout at access to development	
<i>Drawing</i>	60541707 – SHT – 10-C-0100	
<i>Summary</i>	Tactile Paving off Desire Line	
Description		
<p>The tactile paving located on the Lambourne Wood arm of the roundabout appears to be off the desire line for pedestrians crossing. This could lead to pedestrians crossing where no crossing exists and could also cause confusion for visually impaired pedestrians.</p> <p>In addition, tactile paving has not been provided on the development arm or the southern arm of the roundabout.</p>		
Recommendation:		
<p>Tactile paving should be provided at all crossing locations, on the desire line.</p>

<p>5.1.3 Roundabout at access to development</p> <p>Tactile paving should be provided at all crossing locations, on the desire line.</p>	<p>Yes</p>	<p>Yes – Tactile paving now provided at all crossing locations. Please refer to AECOM drawing no. 60541707-SHT-10-C-0101.</p>		<p>Yes</p>
<p>5.1.4 Throughout Brennanstown Road</p> <p>The footpath provided is narrow over the majority of Brennanstown Road and does not meet the recommended minimum width of 1.8m as per DMURS Guidance Document. Provision of a narrow footpath could cause pedestrians to veer into the road carriageway due to lack of space which could cause a collision with a vehicle.</p>	<p>Yes</p>	<p>Yes – Footpath width is 1.8m wide where possible, as per Section 4.3.1 of the Design Manual for Urban Roads and Streets (DMURS). However due to constraints in the Brennanstown Road carriageway width, the footpath width reduces to less than 1.8m for a distance of approx. 30m. Please refer to AECOM drawing no. 60541707-SHT-10-C-0101.</p>		<p>Yes</p>

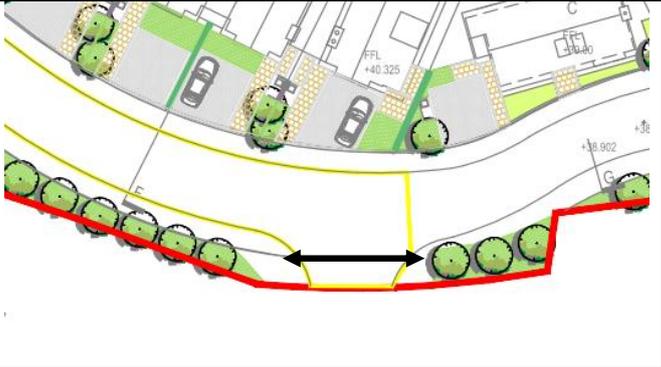
Problem 5.2.1:

<i>Location</i>	Internal Development Road	
<i>Drawing</i>	1395 – 4070	
<i>Summary</i>	No Crossing Facilities	
Description		
<p>It is unclear what the access on the southern side of the access road provides access to and the volume of traffic that will use it. There are no crossing facilities provided for pedestrians across this access arm. Lack of crossing facilities creates a barrier for vulnerable road users.</p>		
Recommendation:		
<p>Dropped kerbs and tactile paving should be provided as appropriate.</p>

Paragraph No. in Safety Audit Report	Problem Accepted (yes/no)	Recommendation accepted (yes/no)	Alternative measures (describe)	Auditor's Accepted Measure
<p>5.2.1 Internal Development Road</p> <p>Dropped kerbs and tactile paving should be provided as appropriate.</p>	Yes	Yes - Dropped kerbs and tactile paving have been included within the proposed layout in accordance with the Traffic Management Guidelines (Department of Environment and Local Government).		Yes
<p>5.2.2 Internal Development Road</p> <p>Ramps should be provided as appropriate in this location to provide access for mobility impaired users.</p>	No		<p>A pedestrian ramp is located immediately south of the steps, which provides access for mobility impaired persons.</p> <p>The ramp connects to a lift which facilitates access to the basement level. Please refer to the submitted landscape drawings.</p>	Yes
<p>5.2.3 Basement Car Park</p> <p>Disabled parking bays in the basement car park should be located close to the lifts/stairwells in each building.</p>	Yes	Please refer to the architects revised basement layout which illustrates disabled parking in locations prominent to the lifts / stairwells.		Yes

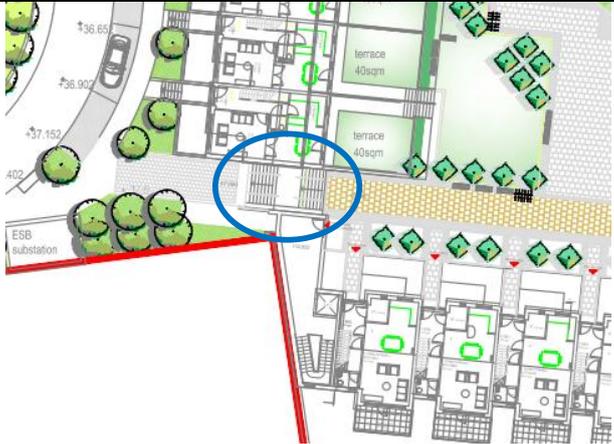
Problem 5.2.2:

<i>Location</i>	Internal Development Road	
<i>Drawing</i>	1395 – 4070	
<i>Summary</i>	Lack of mobility impaired access	
Description		
<p>Mobility impaired access does not appear to be provided at the level change where steps are provided. Lack of appropriate access facilities for mobility impaired users creates a barrier for these pedestrians and causes frustration and exclusion for these users.</p>		
Recommendation:		
<p>Ramps should be provided as appropriate in this location to provide access for mobility impaired users.</p>

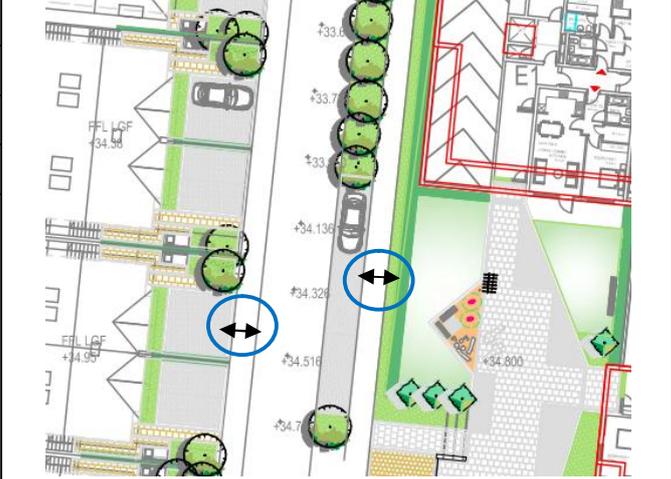
Problem 5.2.4:

<i>Location</i>	Throughout Internal Roads	
<i>Drawing</i>	1395 - 4070	
<i>Summary</i>	Narrow Footpath	
Description		
<p>The footpath proposed appears narrow in sections along the internal roads of the development. Provision of a narrow footpath could cause pedestrians to veer into the road due to lack of space which could cause a collision with a vehicle.</p>		
Recommendation:		
<p>A footpath width of 2.0m should be provided in accordance with the National Disability Authority's Building for Everyone.</p>

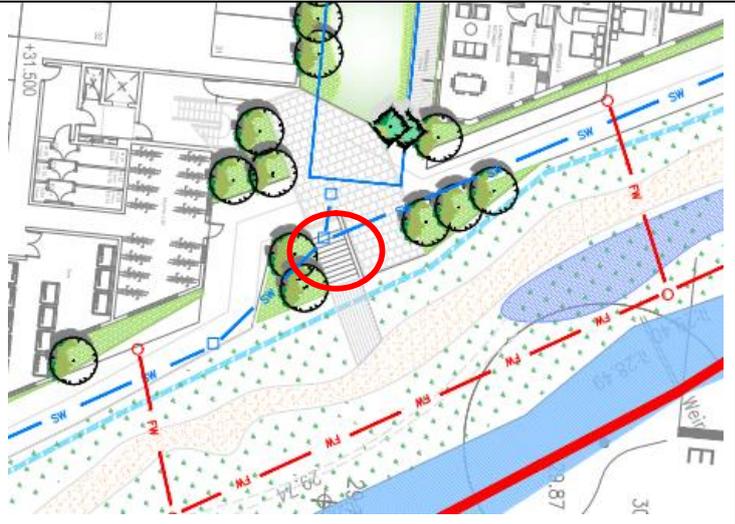
Problem 5.2.5

<i>Location</i>	Raparian Corridor	
<i>Drawing</i>	pS (-01) – 04	
<i>Summary</i>	Lack of mobility impaired access	
Description		
<p>Mobility impaired access does not appear to be provided down to the 'Raparian' amenity corridor with steps provided but no access ramps.</p>		
Recommendation:		
<p>Adequate access should be provided for mobility impaired users to the 'Raparian' amenity corridor.</p>

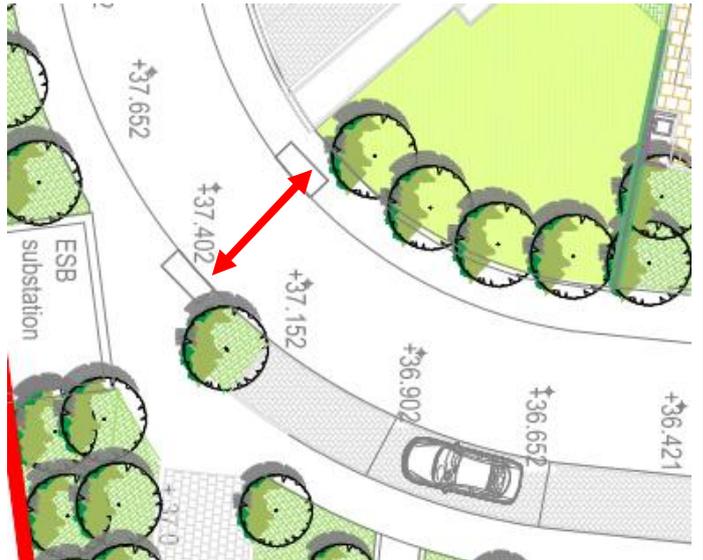
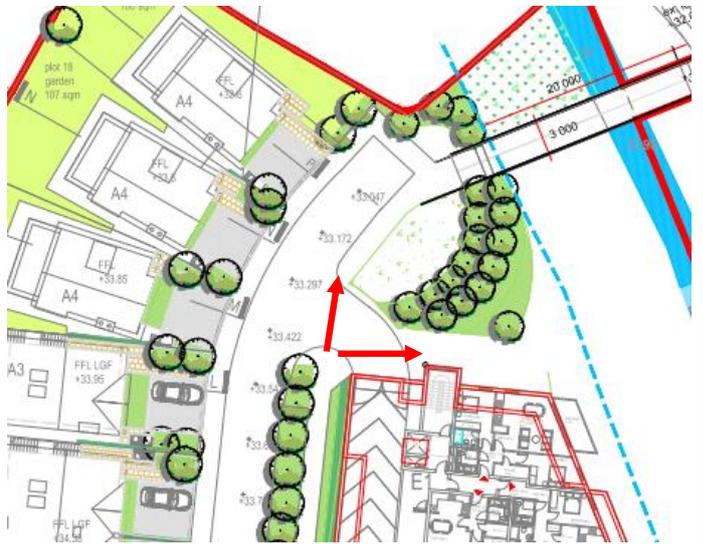
Problem 5.2.6	
<i>Location</i>	Development Road
<i>Drawing</i>	pS (-01) – 04
<i>Summary</i>	Pedestrian Desire Line
<p>Description</p> <p>There are a number of pedestrian desire lines not catered for in terms of tactile paving and/or dropped kerbs, including from the footpath to the ‘raparian’ amenity corridor and across the basement car park access.</p> <p>Lack of crossing facilities creates a barrier for vulnerable road users.</p> <p>Recommendation:</p> <p>Dropped kerbs and tactile paving should be provided as appropriate.</p>

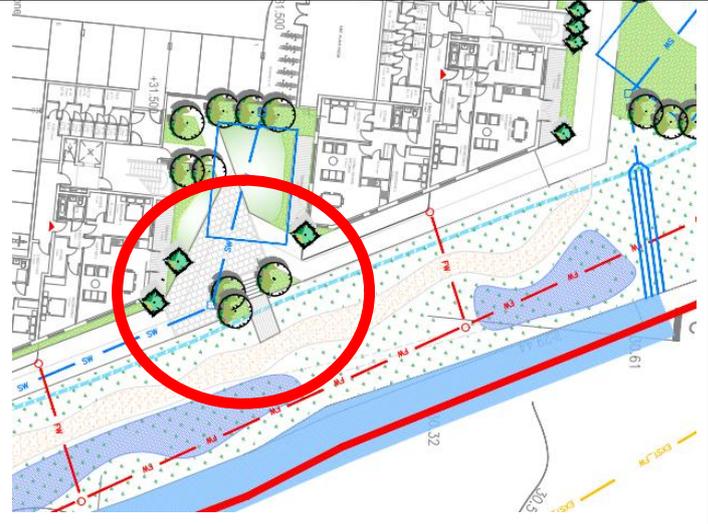
Problem 5.2.9

<i>Location</i>	Pedestrian routes	
<i>Drawing</i>	pS (-01) – 04	
<i>Summary</i>	Steps without handrails	
<i>Description</i>		
<p>It appears from the drawings that steps have been provided throughout the scheme but no handrails have been shown.</p> <p>Handrails are required to reduce the risk of pedestrians falling when using the steps and as an aid for mobility impaired users.</p>		
Recommendation:		
Provide handrails in all locations where steps are provided
